**Flood Control Project Maintenance  
Levee Inspections****LMA District Cover Sheet****Spring 2014 Levee Inspection Results****Sacramento Maintenance Yard Sacramento Bypass**

**Levee Inspection Report By Mile - Spring 2014**

**Sacramento Maintenance Yard Sacramento Bypass**

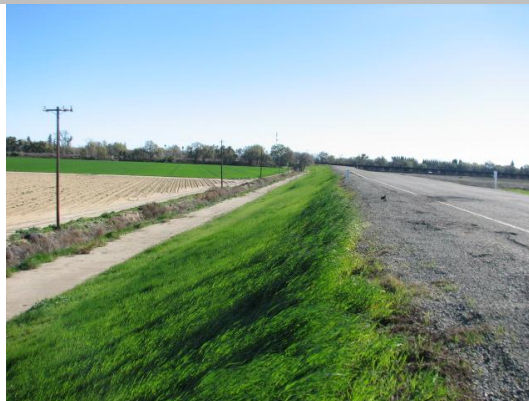
Photo 1 of 1 : johngw\_s\_20140317\_634.jpg

LM Start	0.04	Rating **	A	Issue No.	83
LM End	1.68	Issue Type +	Ma	Location *	LS
Category	Earthen Levee			GPS Latitude/Longitude	
				Start	End
Item	Vegetation			38.606988 °	38.599393 °
				-121.560582 °	-121.589653 °
DWR ID	DWR_ST0008_01_s _ 2014_83				
Action/Comments					
Control annual grass and weeds on the levee slopes and easements.

The grasses on the levee slope is mostly grasses and complies with standards. Spring 2014

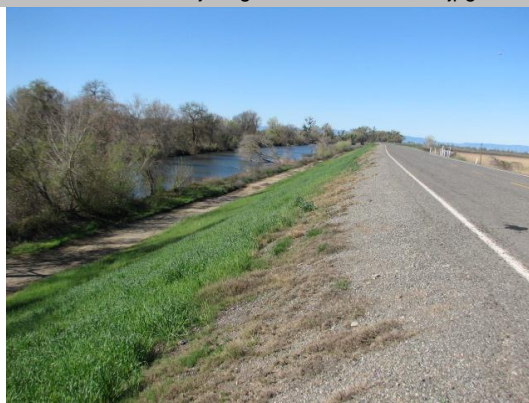
Photo 1 of 1 : johngw\_s\_20140317\_635.jpg

LM Start	0.41	Rating **	A	Issue No.	84
LM End	1.68	Issue Type +	Ma	Location *	WS
Category	Earthen Levee			GPS Latitude/Longitude	
				Start	End
Item	Vegetation			38.604947 °	38.599392 °
				-121.566878 °	-121.589653 °
DWR ID	DWR_ST0008_01_s _ 2014_84				
Action/Comments					
Control annual grass and weeds on the levee slopes and easements.

The slope is mostly grasses and complies with standards. Spring 2014

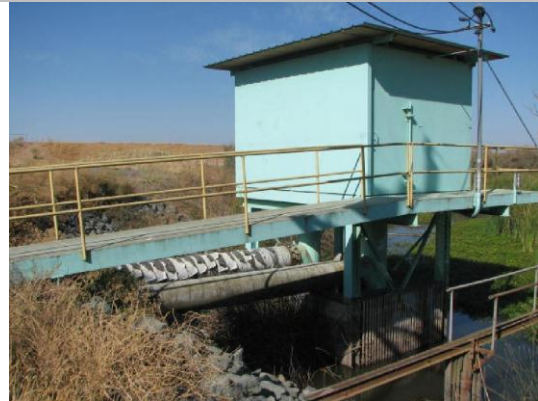
Photo 1 of 1 : UCIP\_693.jpg

LM Start	1.14	Rating **	M	Issue No.	81
LM End	1.14	Issue Type +	En	Location *	LS
Category	Supplemental			GPS Latitude/Longitude	
				Start	End
Item	DWR UCIP Field Study			38.602180 °	38.602180 °
				-121.579130 °	-121.579130 °
DWR ID	DWR_ST0008_01_s _ 2014_81				
Action/Comments					
Inspector Comments: FS_ID:12703					
EP_NO: 13616					
Repair Type:					
Crossing Status:					
UCIP Comments: After more investigation depressions are from water run off. erosion repair needed					
FIELD_STRUCT_DESC: 1 of 2. A agriculture drainage pumping system with 24-inch and 20-inch steel discharge pipelines through the north levee of the Sacramento Bypass. The pipe is 6.33 ft below the crown and a siphon breaker on the WS. Vertical GI pipe trash rack on inlet structure. Application no. 13616, 1995 (revised).					
FS Date: 5/7/2013 9:09:11 AM

Landside view: pumping plant overview

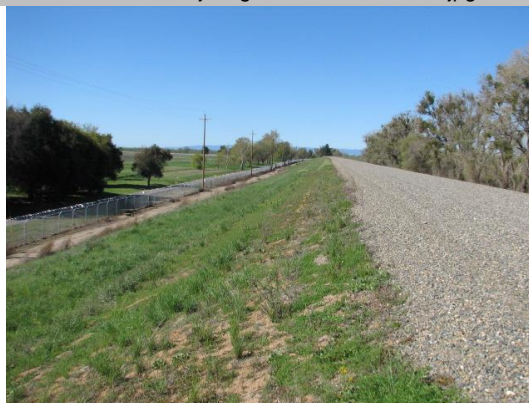
Photo 1 of 1 : johngw\_s\_20140317\_636.jpg

LM Start	0.02	Rating **	A	Issue No.	1
LM End	1.73	Issue Type +	Ma	Location *	LS
Category	Earthen Levee			GPS Latitude/Longitude	
				Start	End
Item	Vegetation			38.602635 °	38.594575 °
				-121.555910 °	-121.586709 °
DWR ID	DWR_ST0008_02_s_2014_1				
Action/Comments					
Control annual grass and weeds on the levee slopes and easements.

The vegetation on the slope complies with standards. Spring 2014

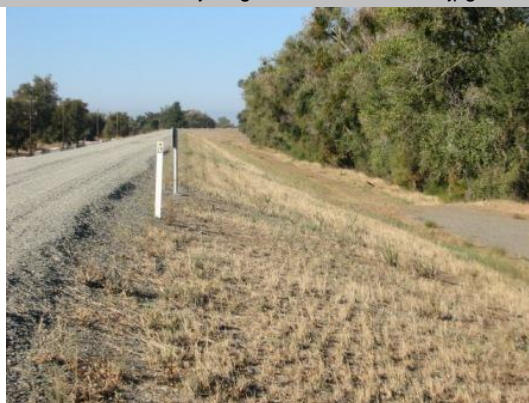
Photo 1 of 2 : johngw\_s\_20140306\_588.jpg

LM Start	0.48	Rating **	A	Issue No.	4
LM End	1.76	Issue Type +	Ma	Location *	WS
Category	Earthen Levee			GPS Latitude/Longitude	
				Start	End
Item	Vegetation			38.600453 °	38.594775 °
				-121.563968 °	-121.586535 °
DWR ID	DWR_ST0008_02_f_2013_4				
Action/Comments					
Control annual grass and weeds on the levee slopes and easements.

The levee has no unwanted vegetation. Fall 2013

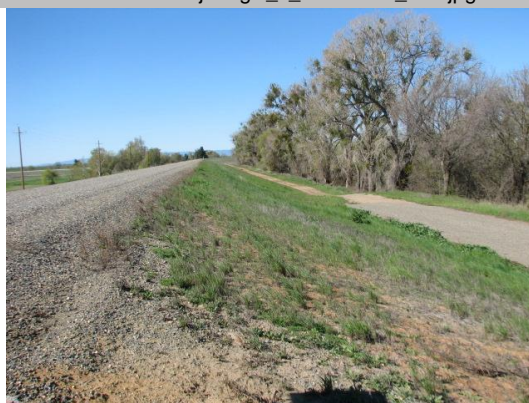
Photo 2 of 2 : johngw\_s\_20140317\_637.jpg

The vegetation on the slope complies with standards. Spring 2014

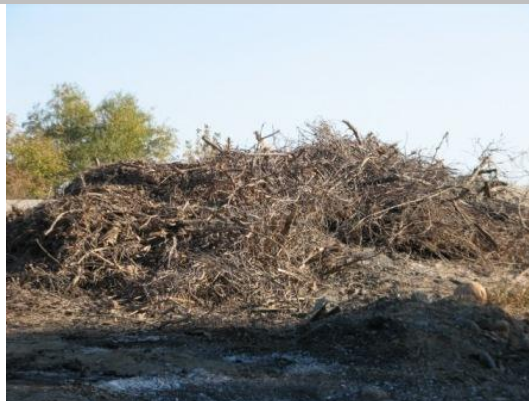
Photo 1 of 2 : johngw\_s\_20140306\_589.jpg

LM Start	1.76	Rating **	M	Issue No.	5
LM End	1.76	Issue Type +	En	Location *	LS
Category	Earthen Levee			GPS Latitude/Longitude	
				Start	End
Item	Encroachments			38.594777 °	38.594777 °
				-121.586525 °	-121.586525 °
DWR ID	DWR_ST0008_02_f_2013_5				
Action/Comments					
Prunings

The never ending pruning pile at the end of the unit. Fall 2013

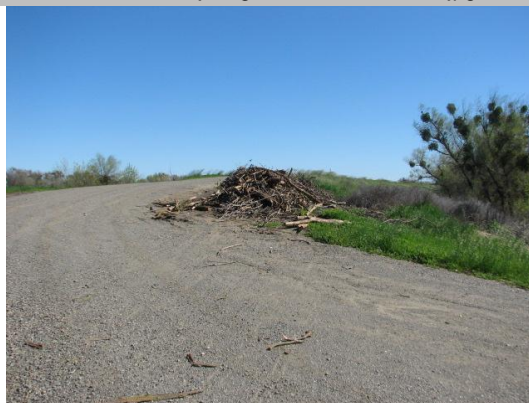
Photo 2 of 2 : johngw\_s\_20140317\_638.jpg

This is this years pile of brush and will be burned by the maintenance yard. Spring 2014
